Brian Bugge Incident – 20 May 2018
City and County of Honolulu, Hawaii
Dept. of the Medical Examiner
Case No. 18-1242

Timeline of events relevant to the dive that took place on
20.5.2018 07:49:58

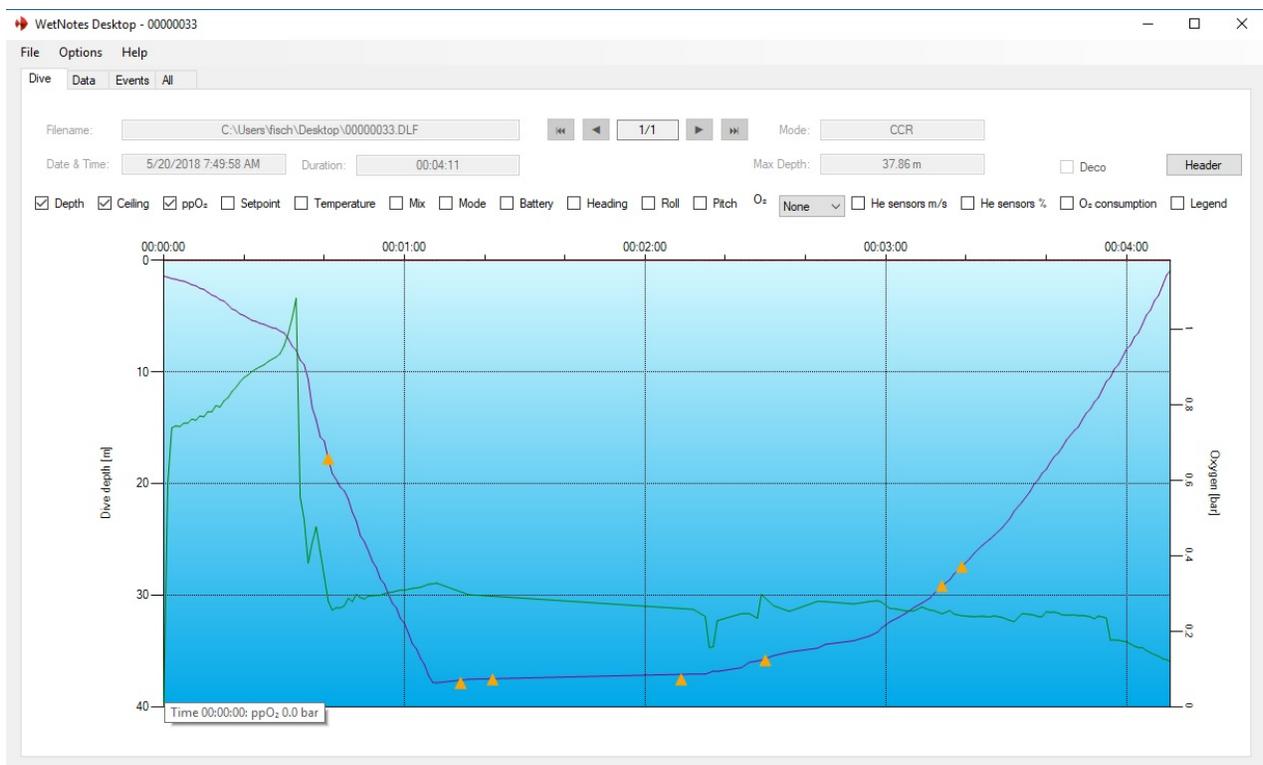
Dive Profile

The first and last known and verifiable ppO₂ reading from the O₂ cells is: 0.05bar (2.34mV), 0.04bar (1.76mV), 0.04bar (1.94mV), 0.04bar (1.82mV). This occurred at the switch on to CCR mode at 1.5m depth. After this, we cannot verify that the readings are correct because the unit became flooded with sea water and the sensors' ability to accurately read oxygen became corrupted. Nevertheless, the oxygen solenoids fired repeatedly throughout the dive but the ppO₂ continued to fall after an initial spike, likely caused by an increase of water pressure during the descent and possibly an initial short burst of residual oxygen in the oxygen hose.

The verified oxygen levels are well below the ppO₂ required to sustain consciousness (0.16 bar). This supports the conclusion that the diver lost consciousness at or near the surface. Furthermore, as the diver descended to the bottom, multiple alarms were given by the rebreather but none were acknowledged by the diver.
